Archaeological Investigations at Fishergate Postern Tower, Piccadilly, York

YAT Assessment Report 2019/6 January 2019

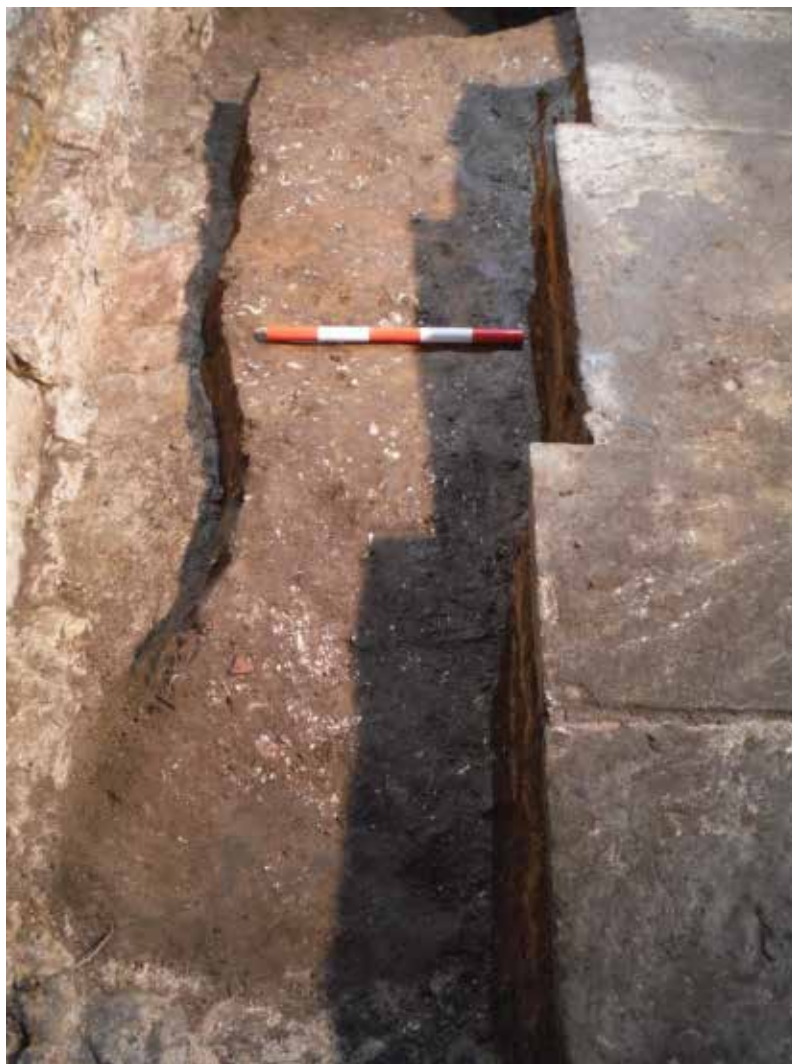
Plate 1 West facing view of Context 1042, a dump deposit pre-dating the construction of the tower (0.50m scale)

Dating evidence was limited as the deposit contained few finds. Alongside a small amount of Roman brick and colour coated ware, however, a single sherd of a Humber type earthenware was recovered, which is likely of 14th to early 16th century date and corresponds well with the construction date of the tower. A single intrusive sherd of 18th/19th century English stoneware was also recovered; this was likely introduced to the context through later disturbance.

The upper surface of the deposit was located at a height of 9.62m AOD and it continued beyond the maximum excavated depth of 9.29m AOD.

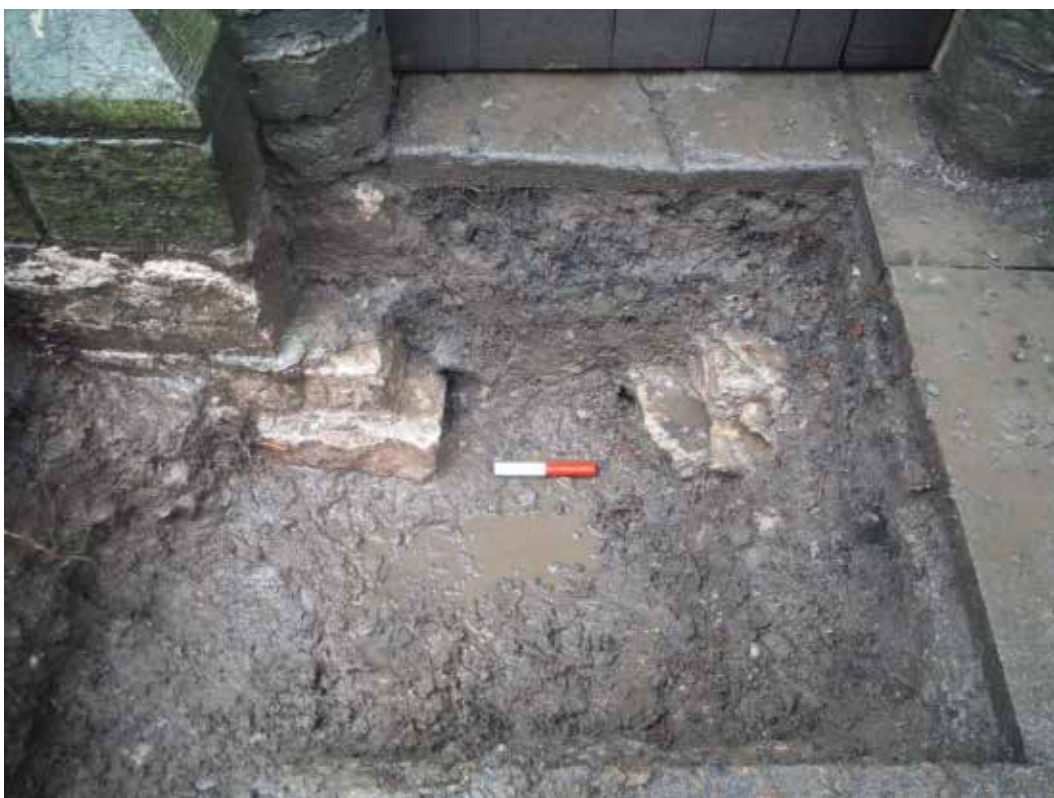
Plate 2 West facing view of Group 1007, stone footings below the tower threshold (0.20m scale). The north footing on the right side of the image is not built directly below the door jamb.

In the external excavation area, two small areas of substantial limestone footings were observed below the current threshold (Group 1007; Figure 4; Plate 2). The footings were made of roughly faced magnesian limestone blocks bonded with a lime mortar and were exposed to a height of 0.25m and up to 0.39m across.

The southernmost of the two footings (Context 1044) was built directly below the south side of the door jamb. The northernmost (Context 1043) was not built directly below the north side of the door jamb, instead being built offset approximately 0.20m to the south (Plate 2). As only a small area of the footings was exposed, the reason for this is unclear at present.

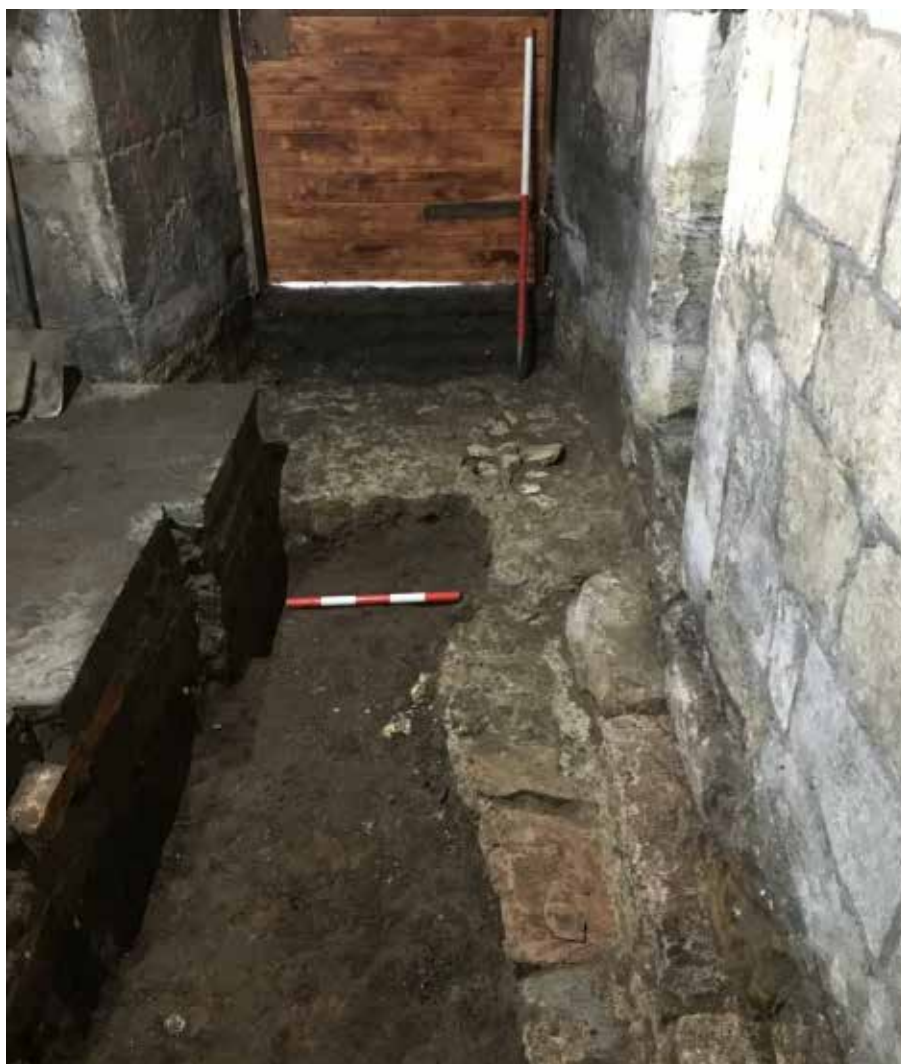
Plate 3 East facing view of exposed tower wall core (Set 1030) below the threshold and the footings of the internal wall (Set 1029; 1.00m and 0.50m scales).

Following the construction of the main external walls, an east/west aligned internal wall (Set 1029 in Group 1015; Figure 4; Plate 3) was added to the south end of the building to house the spiral staircase. The wall abuts the main east and west walls of the tower and the construction cut of the northern face of the wall was fully exposed in plan within the current excavation area. The construction cut was roughly linear in plan and measured 2.75m in length and up to 0.66m in width. The cut was excavated to a depth of 0.33m (9.44m AOD) to expose the wall footings, although its full depth remains unknown.

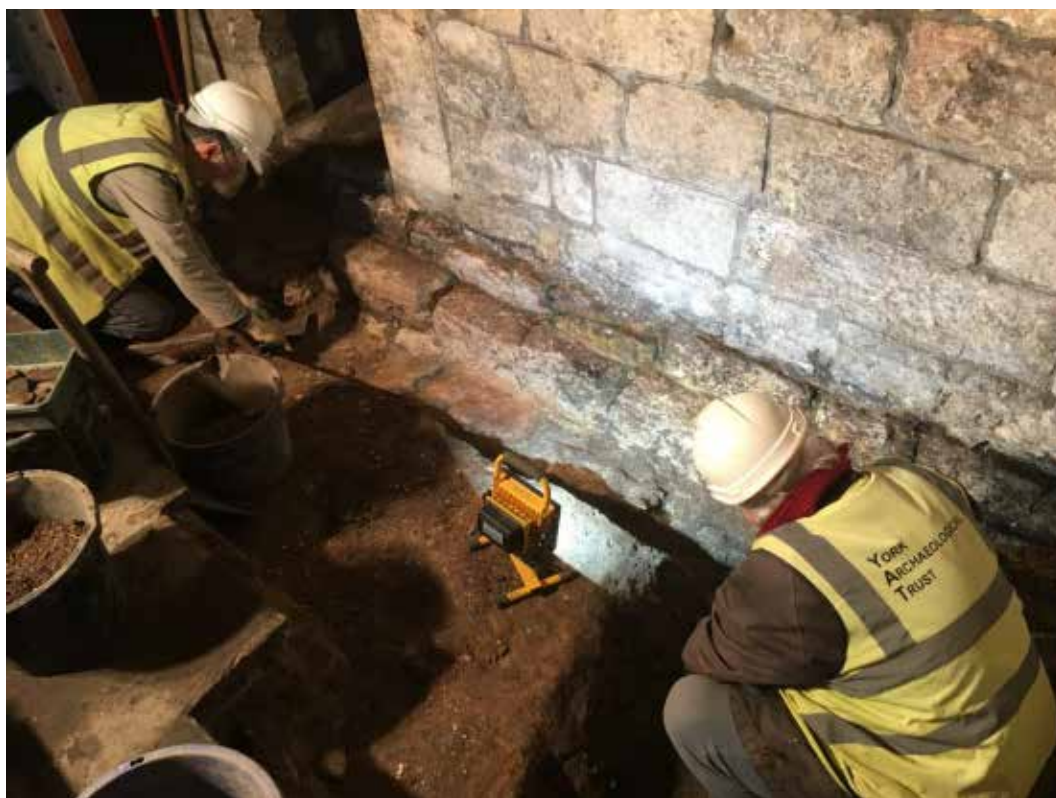
Plate 4 South-east facing working view of the internal wall footings (Set 1029) being exposed.

Three courses of the footings of the internal wall were exposed during the excavation (Group 1015; Figure 4). From a height of 9.80m AOD at the base of the standing wall, the footings stepped out three times to a maximum width of 0.51m, with the lowest course built at 9.47m AOD (Plates 3 and 4). The full depth of the footings is presently unknown.

Roughly rectangular blocks of magnesian limestone measuring up to 0.85m x 0.22m were the predominant building material, although some sandstone blocks were also present; a pale grey lime mortar was used throughout. The sandstone may represent recycling of masonry and in some cases was in very poor condition. The footings were covered with a construction backfill deposit of mortar and sandy clayey silt. Alongside a small amount of animal bone, a small assemblage of Roman pottery and 13th-16th century tile was recovered from this deposit.

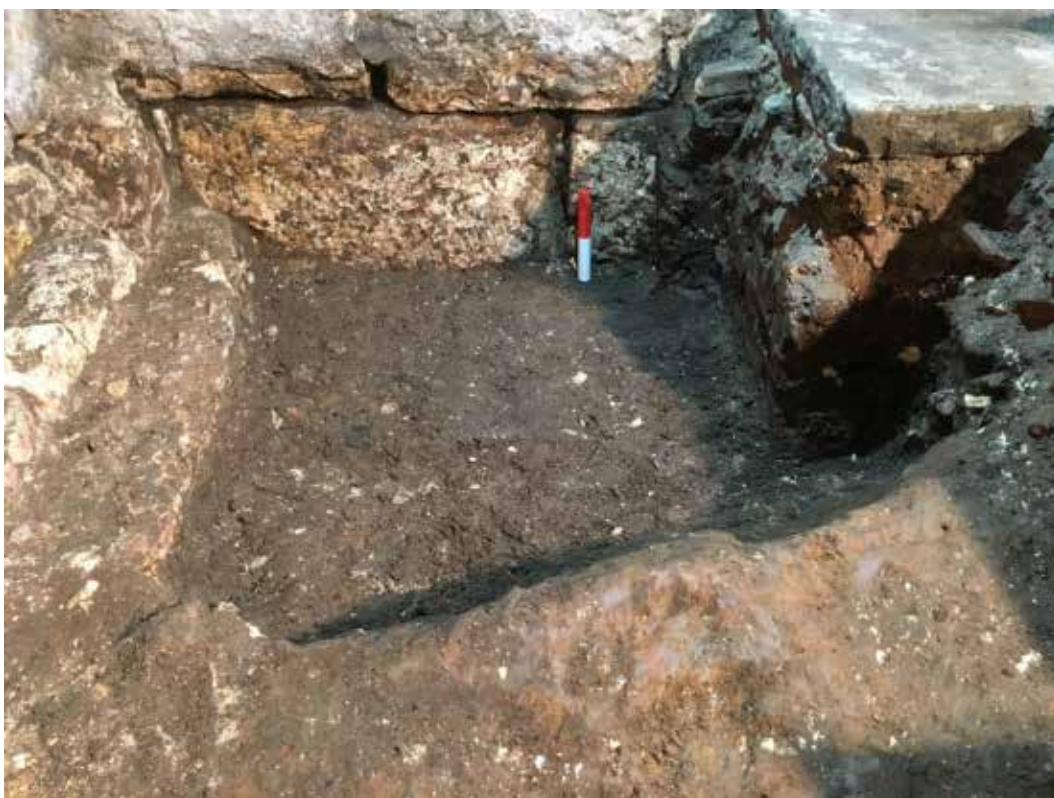
Plate 5 West facing view of 16th century pit (Set 1028) cutting into the construction backfills of the tower (0.20m scale).

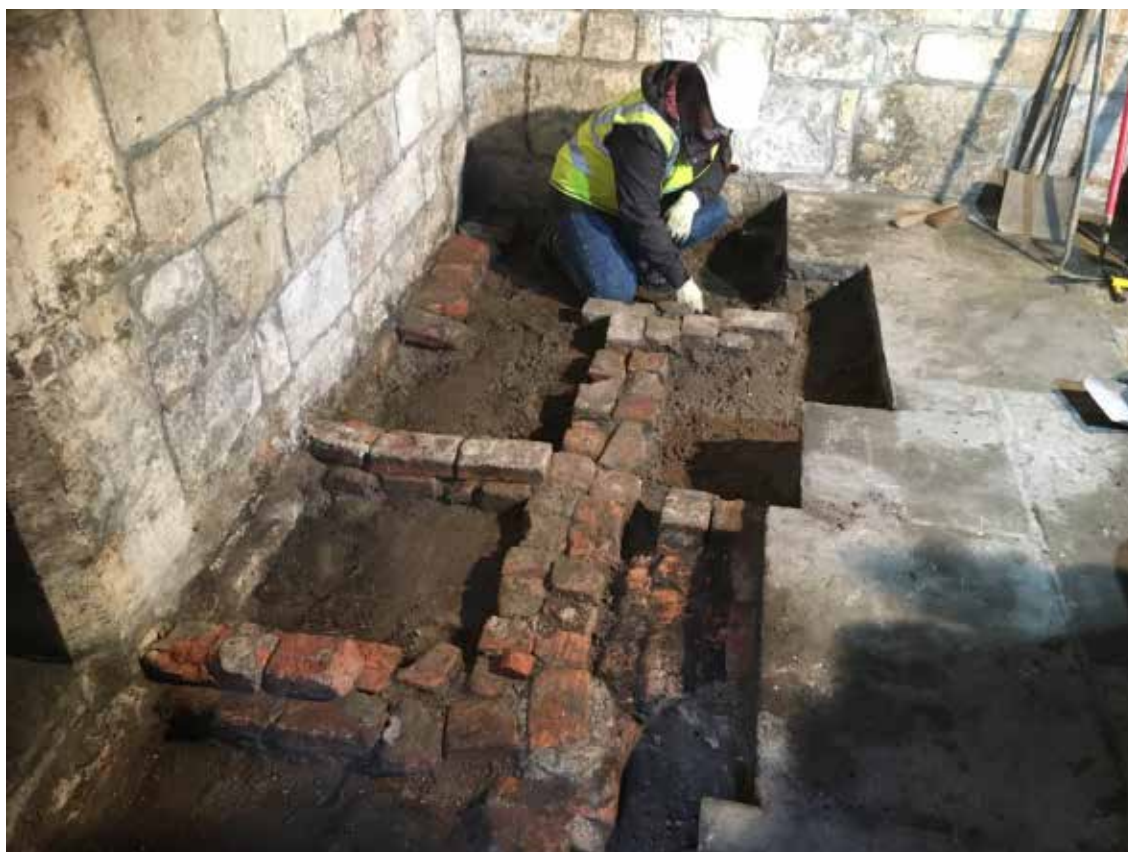
Plate 6 Working shot of brick footings and floors being investigated (Groups 1009 and 1010), looking west. The entrance to the former staircase would be to the immediate right of the archaeologist.

The principal structure was an east-west aligned, L-shaped group of un-mortared footings comprised of re-used medieval and post-medieval brick and brick fragments; the latest brickwork was dated between the mid-18th and mid-19th centuries (Group 1009; Figure 8; Plate 6). As a whole, the footings measured 2.62m x 1.35m and survived to a maximum of two courses in height at 9.81m AOD. These structures were interpreted as the footings for a timber staircase that formerly provided access to the first floor.

The internal layout of the tower underwent numerous changes in the 18th and 19th centuries. The footings of a timber staircase and an associated brick floor dating to this period (Groups 1009, 1010 and 1011; Figure 8; Plates 6 and 7) had survived in good condition after the superstructure was dismantled in 1960 (RCHME 1972, 156). The L-shaped footprint of the footings demonstrated that the foot of the stairway would have faced northwards and was built flush to the west wall of the tower. The steep angle of the staircase is still visible as a mark in the wall (Plate 11).

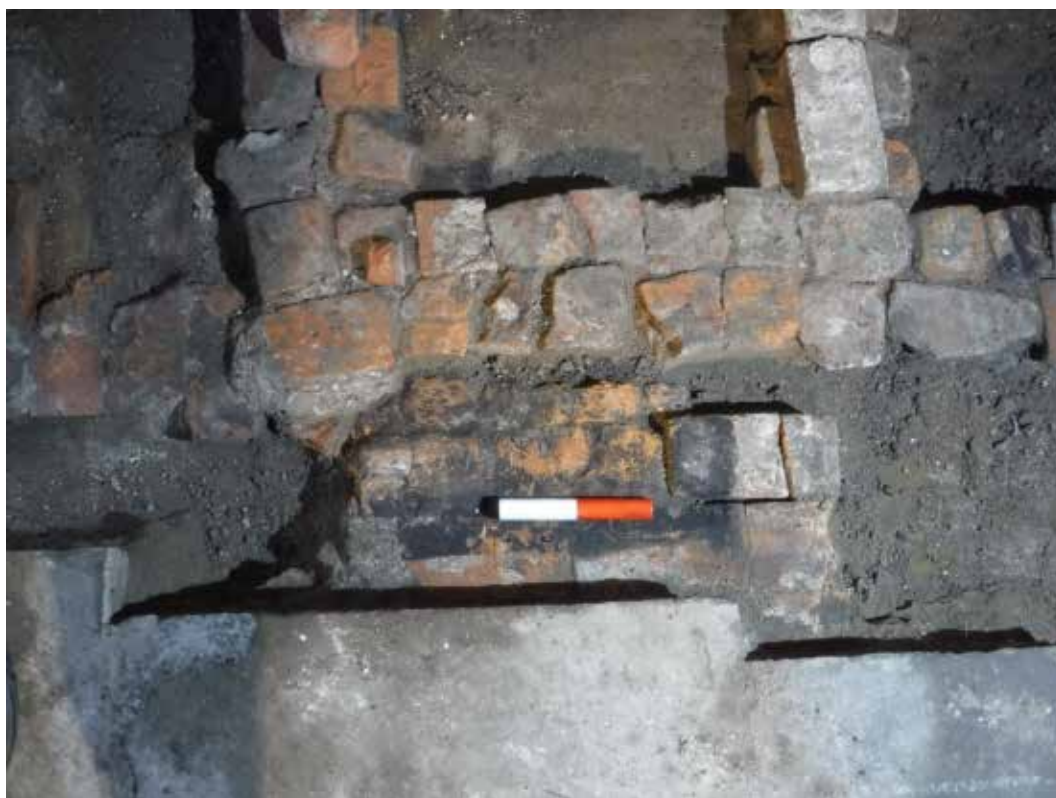
Plate 7 South facing view of Context 1008 (in Group 1010) with rectangular sooting pattern (0.20m scale).

Following the construction of the staircase, a brick floor was built flush to the footings, and two small areas of this brick floor survived within the excavation area (Contexts 1005 and 1008 in Group 1010; Figure 8; Plates 6 and 7). Both surfaces were a single course in height (9.70m AOD) and made of un-mortared, re-used 16th-18th century brick with a worn upper surface. The westernmost of the two surfaces (Context 1008) featured a clear rectangular pattern of sooting on its upper surface and increased ware at its junction with the staircase footings (Plate 7).

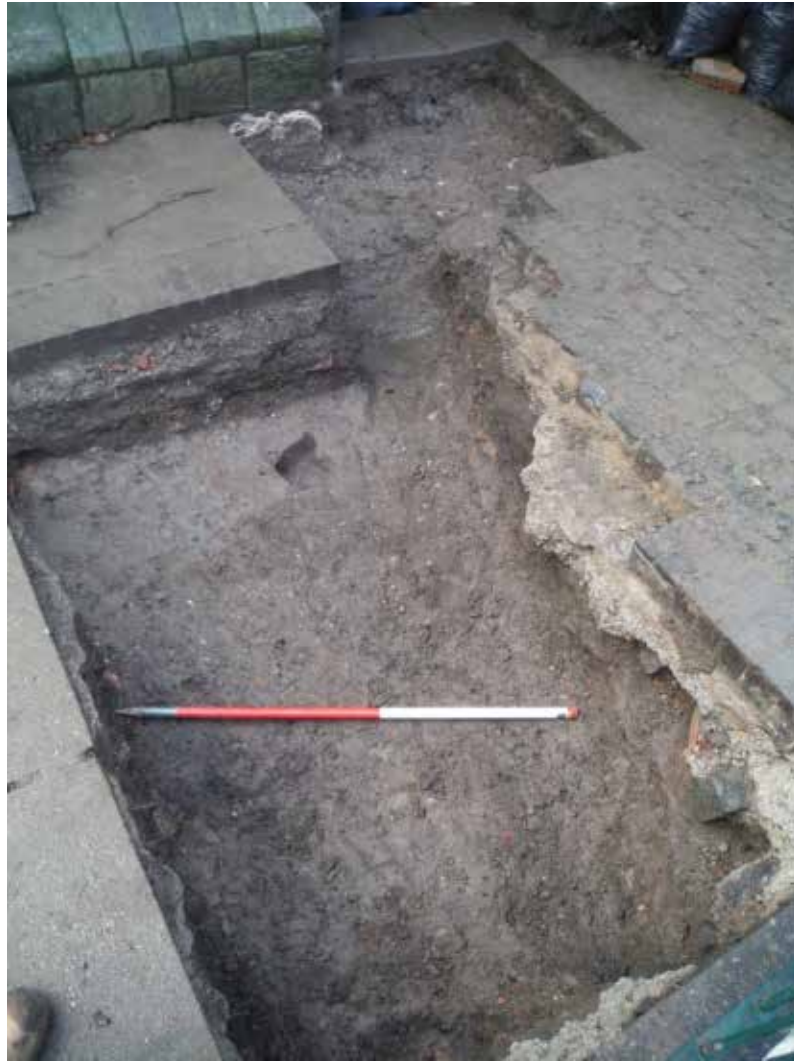
Plate 8 North-west facing view of 19th century levelling deposits (Group 1006, 1.00m scale).

A further mixed levelling dump with frequent CBM fragments (Context 1028 in Group 1005; Figure 10) raised the ground level up to 9.60m AOD. This was overlain by another dump deposit (Context 1024 in Group 1004; Figure 10) at the eastern limit of excavation and cut by a shallow linear cut feature closer to the tower (Context 1027 in Group 1004; Figure 10). Only a small area of this rectangular cut was exposed; measuring 0.46m x 0.38m x 0.16m and dated to the 19th century by ceramics and a fragment of fired clay tobacco pipe stem.

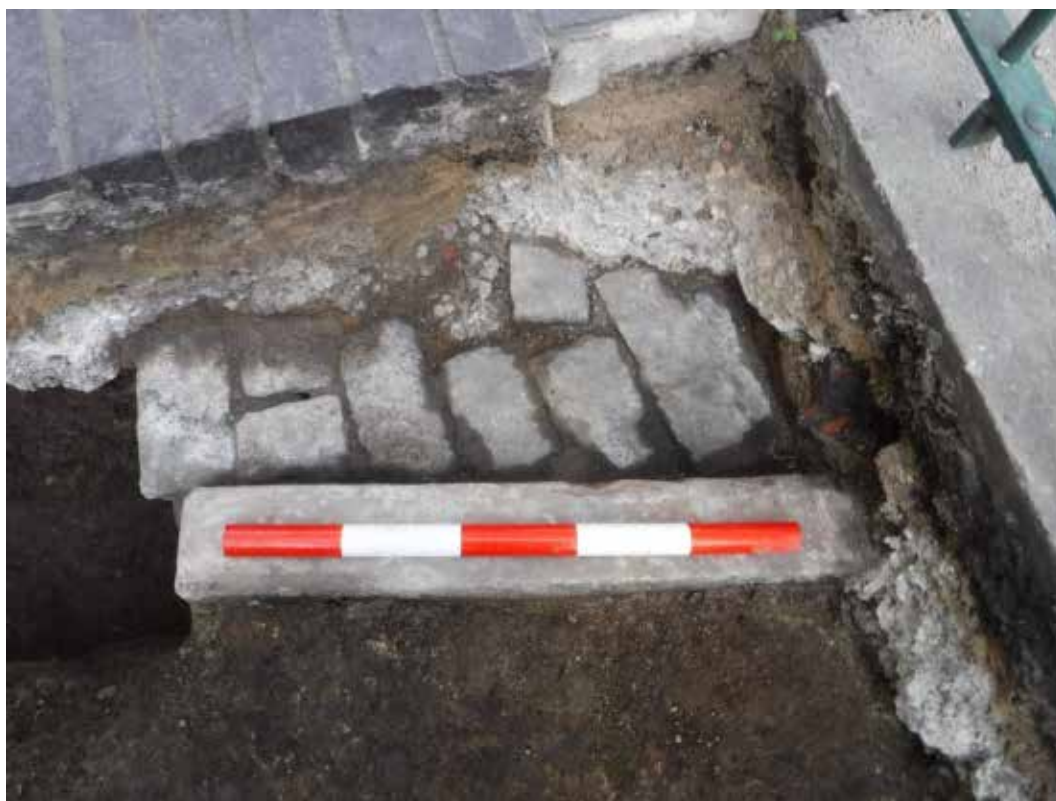
Plate 9 North-east facing view of a 19th/20th century paved surface (Group 1002). Group 1001, a robber cut, is visible in the left of the image (0.50m scale).

The final feature within this phase was a 0.62m x 0.35m area of a stone sett surface in the north-east end of the excavation area (Context 1014 in Group 1002; Figure 12; Plate 9). The surface was heavily truncated but well-laid, with rows of rectangular granite setts laid on edge against a north-east/south-west aligned sandstone kerb. A small amount of bitumen was used as bonding material and the setts were laid in a thin bed of sand, with no concrete or rubble foundation. The alignment of the kerbing would suggest that this was a pathway leading to the door of the tower.

The surface of the kerbstone stood 50mm proud of the make-up material that the surface is cut into (Context 1017), suggesting that a surface of flagstones may have previously been laid against the kerb. This surface was tentatively dated to the early 20th century.

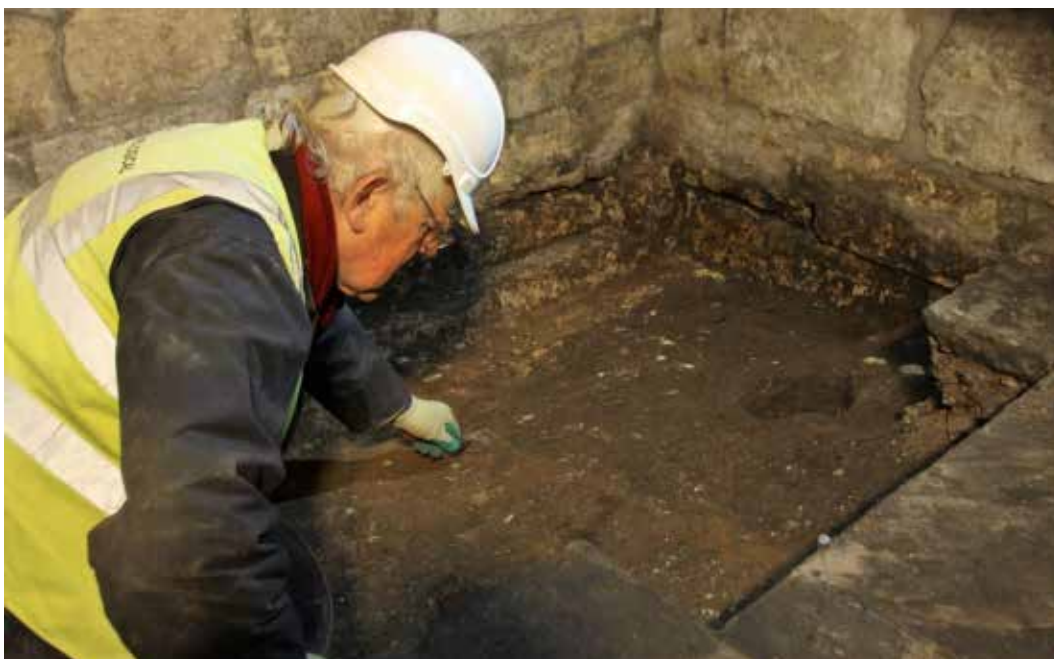
Plate 10 Working view of a medieval pit (Set 1028) being cleaned prior to excavation, facing south-west.

The single, partially-excavated pit that formed the sole feature within this phase provides evidence of activity immediately post-dating the construction of the tower (Set 1028; Figure 6; Plates 5 and 10). The finds assemblage did not provide a tight date for the feature as it primarily comprised re-deposited Roman and early medieval ceramics. Refuse pits are not typical features within standing buildings of this period, however, construction work may still have been in progress when the pit was dug.

As the pit only received limited investigation, a further possibility must be considered. The pit's stratigraphic relationships with the surrounding deposits were very clear in plan; however, the southern edge of the cut was noted to be quite diffuse during excavation. It therefore remains possible that the pit actually pre-dates the construction of the south tower wall (Set 1029). If this interpretation were proved to be correct, this feature would less likely represent a pit that obscures the construction cut of the west wall of the tower, rather the construction cut itself. As the archaeological resource beneath the floor of the tower is well-preserved, this ambiguity could certainly be resolved with further excavation.

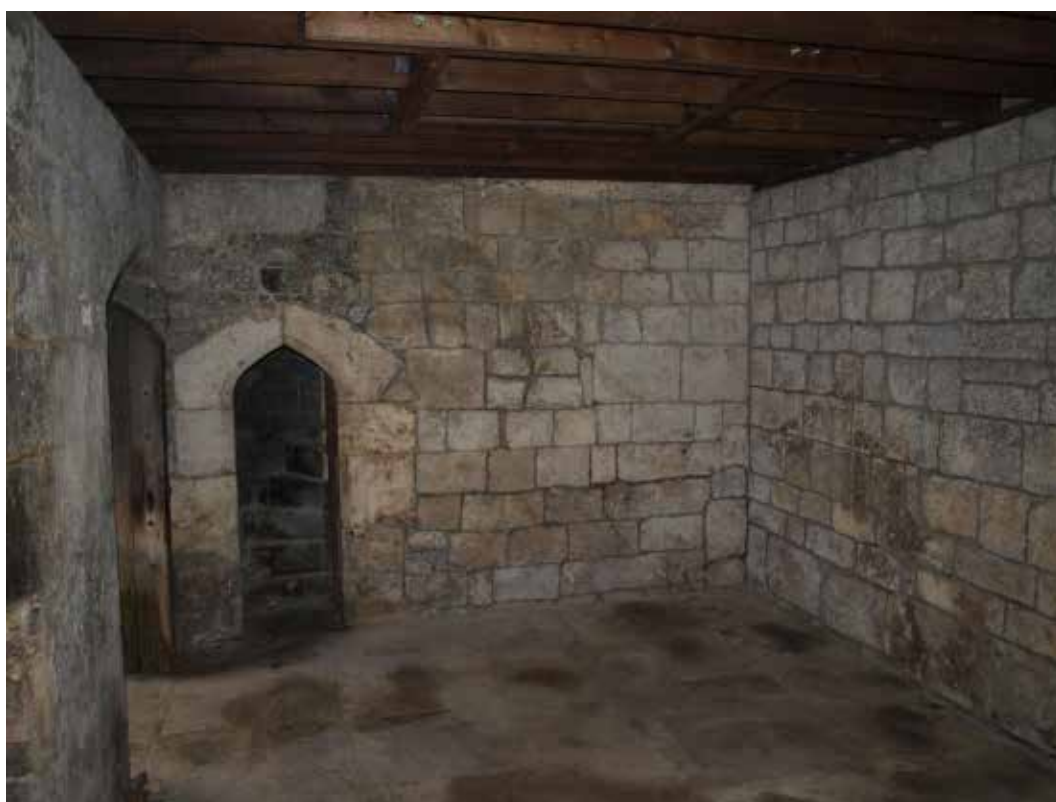
Plate 11 South-west facing pre-excavation view of the south internal tower wall (Group 1015). A diagonal mark in the wall descending left to right shows the location of the former staircase (Group 1009). Image courtesy of Friends of York Walls.

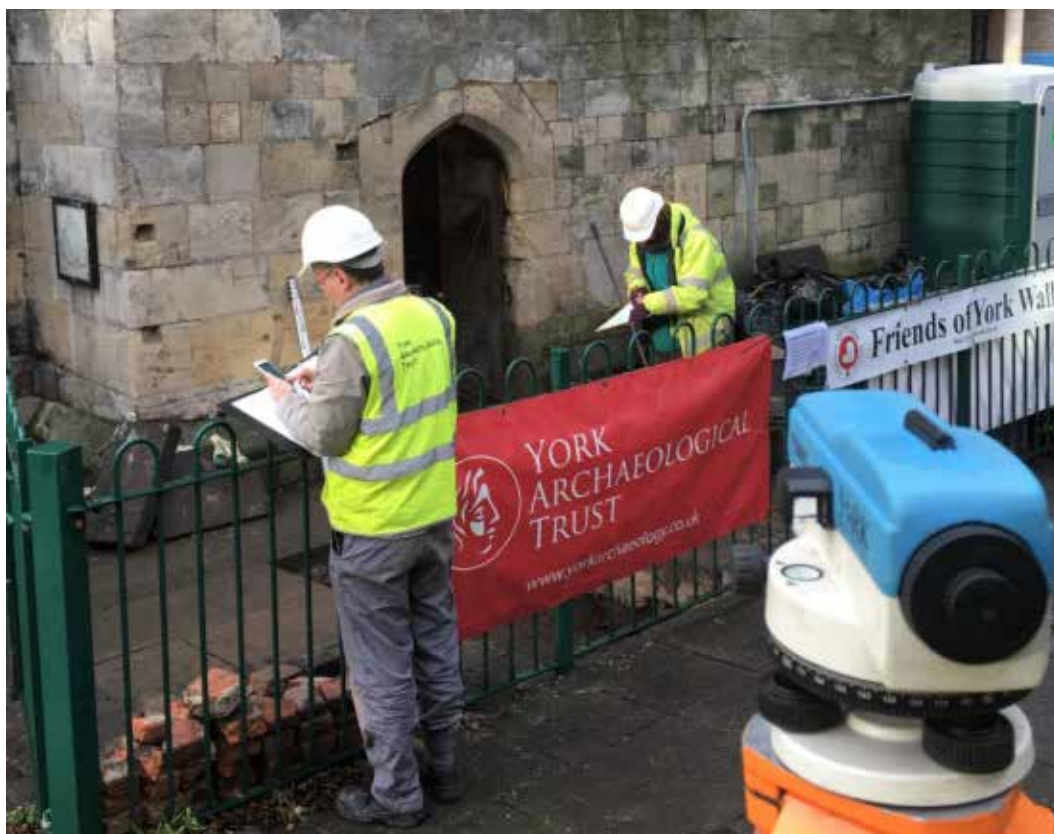
Plate 12 Working shot of archaeological recording, facing north-east. Putlog holes are visible in the wall to the left of the doorway.
