Fishergate Postern Tower

This booklet tells you about the tower, its history and some of the many mysteries which are linked to it.

Friends of York Walls

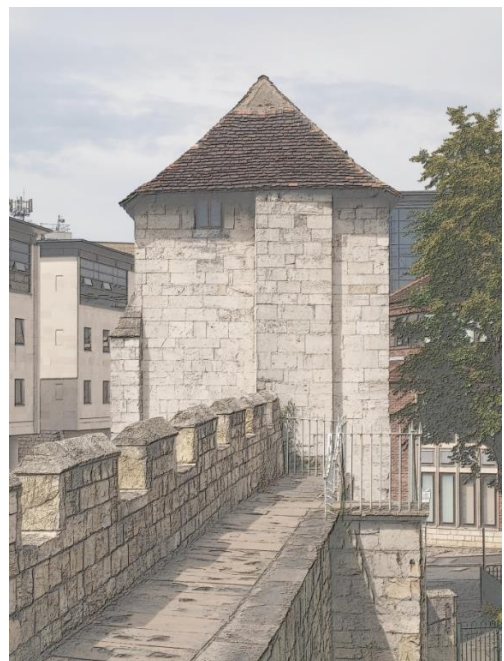
Architecturally, the tower has neatly laid, smooth cut blocks of magnesian limestone. Rectangular buttresses stick out from the west corners. The walls haven't been altered except by unsuitable repointing with cement (the original lime mortar is better). It has a moulded plinth at the base on the east, west and south sides. This plinth drops in stages to the north and is not visible on the north side because the land once dropped steeply there, dropping down to the river. The hipped, tiled roof has small gables (or 'gablets').

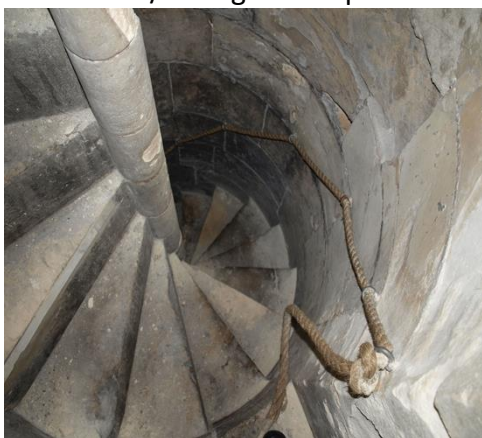
The door to the tower is at ground level on the city side of the city walls. The room here is the smallest in the tower as its walls are the thickest. Its window looks north where the land plunged down to the river. It has a big open fireplace. The photo above shows the pointed archway to dark, narrow, spiral stone stairs that wind steeply up to the other floors. You can see traces on the walls of where there was a wood staircase, entered along the wall to the right then going steeply up to the left; this reached the first floor just above the arch. It's a bit of a mystery but someone, sometime after 1818, wanted modern wood stairs. These stairs were removed in 1960 and new wood floor/ceilings were put in for all floors but little else was changed. The remaining, Tudor stairs are narrow, so if you go up, please go carefully.

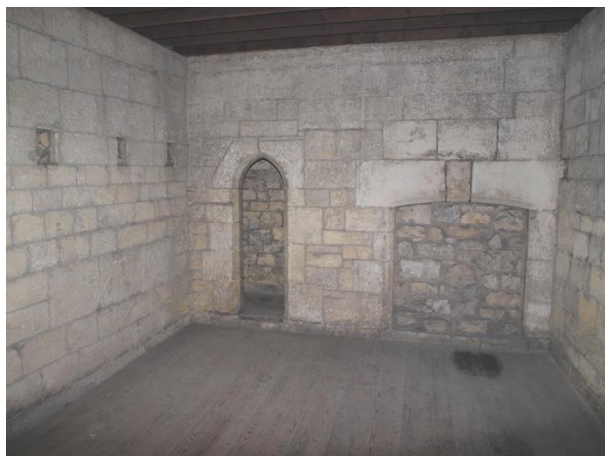
The first floor is through the first door up the stone spiral staircase. This floor has a blocked fireplace on the coldest wall, the one facing north. The fireplace has a shapely stone surround which is oddly clean for the surrounds of an open fire. There is what is probably a Tudor mason's mark cut neatly into the bevelled lower edge of the main stone on the left; such marks are explained on page 7. Shallow square holes, at about head-height in the east and west walls have no obvious purpose, they are another little mystery.

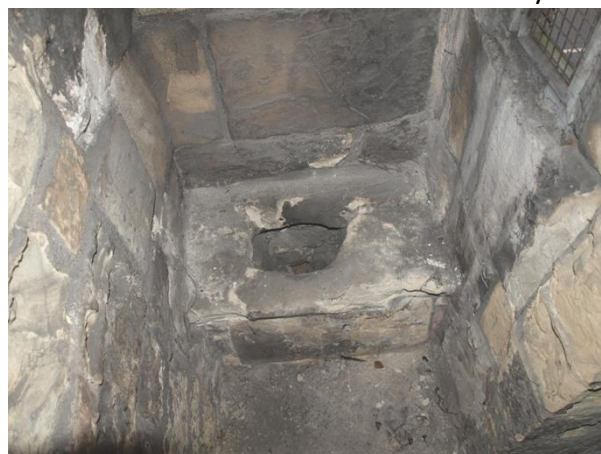
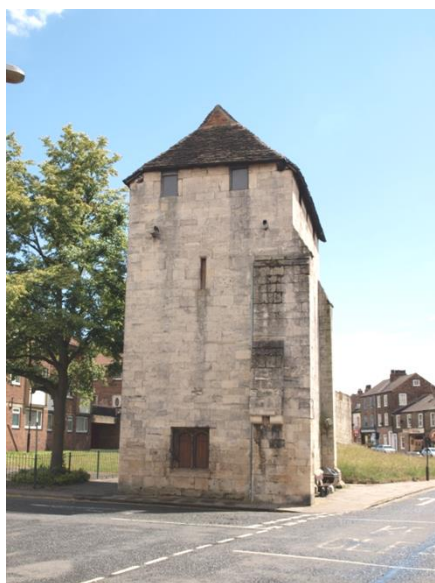
To the left of the fireplace is something with a very obvious purpose: a short narrow passage leads left within the thickness of the wall to a 'Garderobe' or medieval-style toilet. The part of this toilet where you can sit sticks out from the main northern wall of the tower. This projection has a small window and is supported on stone corbels under it.

There is a modern nail in the wall facing the "Garderobe" – perhaps a modern joker put it there to hold a toilet roll! Not a Friend of York Walls we hasten to add. Historic England must give permission before anything is fixed into the walls. We put in Tudor-style toilet wipes –leaves, wool and moss.

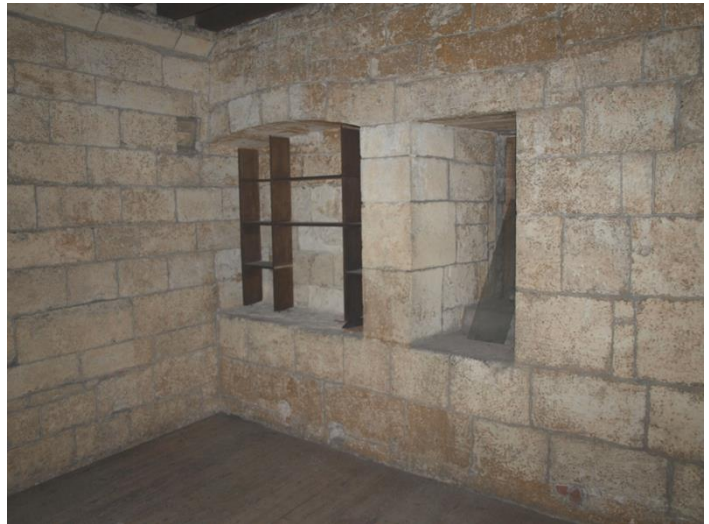
There is no sign of a fireplace on this floor but there's a mysterious arched recess in the north wall. What could it have been for? –the photo above seems to suggest use as a bookcase but this use isn't likely in early Tudor times!

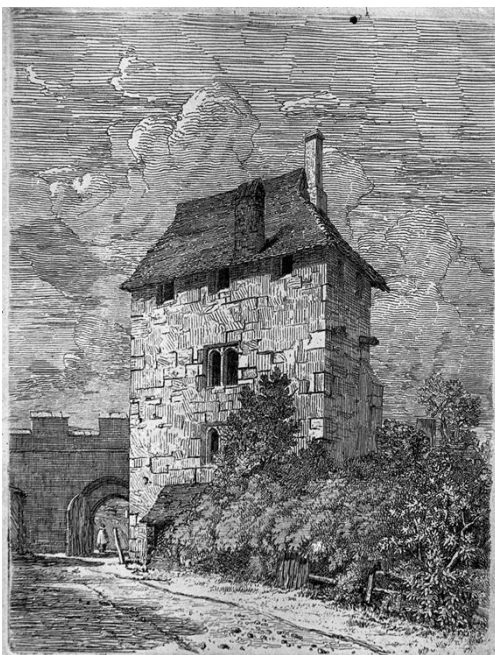
Early 19thC view [?] with hinged gate to postern

It has a pointed arch with portcullis slots about 12 cm. wide – a portcullis is a gate which slides down slots to close. Metal fixings remain for a hinged gate that would have opened inward (see p.6 view). Both sorts of gate still exist at Walmgate Bar, a larger gateway into York, 400 metres east of the postern. Cooper {4} writes of "a strong oak door, the crooks of which remain" at the postern. The wall here is almost 2 metres thick and 7 metres high including the parapet. There is no access from the postern tower to the wall-walk above the postern (see lower picture p.3). But it would have needed a winch on the wall-walk above the gateway to raise a portcullis that was roughly 3 by 1.5 metres in size.

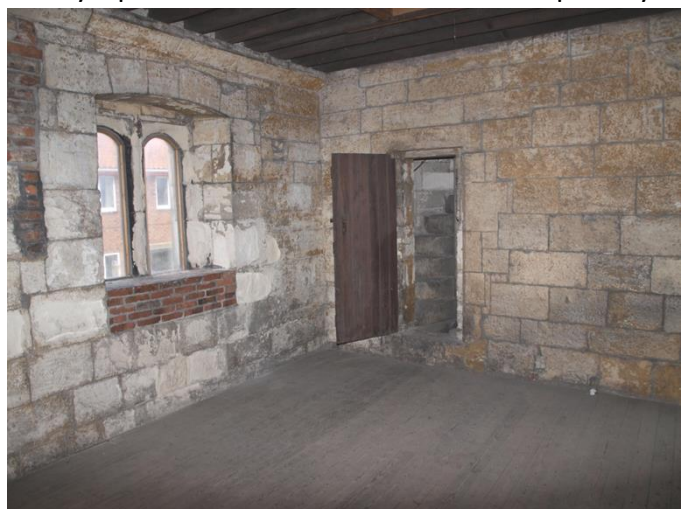
More of a mystery is that William Hargrove {3} in 1818 wrote that a poor freeman of the city inhabited the tower where "a flight of winding stone steps led to the top. About half way up these steps is another room, with other conveniences and at one end of it a curious gallery in the form of a music gallery of a modern assembly room; it is railed around and is entered from a door above, from the winding staircase". So it seems the present second floor was mainly open to the floor below with the part by the

The second floor was probably replaced in 1838, as there was restoration then.

Much less of a mystery is the ledge on the top of the east and west sides of this room –this probably supported the roof beams because this was planned to be the highest room in the tower. Probably a flattish roof was seated there for almost a century; there's more about the roof on page 7.

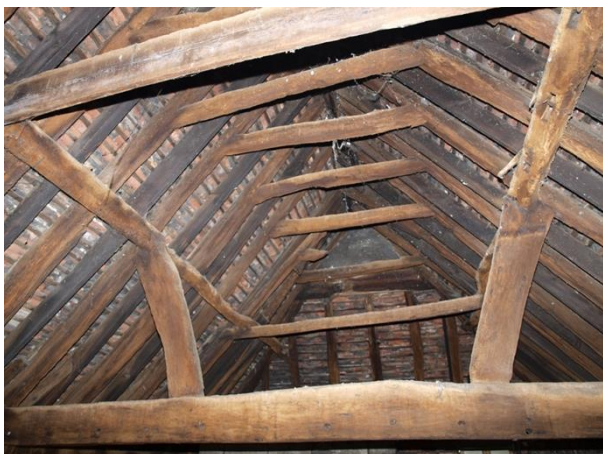
THIRD / TOP FLOOR

with a pointed roof, possibly the current roof which looks pointed from the south. The roof looks similar to today's roof in a 1678 drawing by Lodge, (see p.1).

The stairs continue climbing after this floor. They rise to a small stone platform which presumably was once the floor, or part of the floor, of a look-out tower about 2.5 metres higher than the walk behind the battlements. Most think this roof was added before 1610 to a tower which had had battlements, a look-out tower and a flattish lead roof for some years.

In the north wall are traces of the chimney shown smoking in the 1678 drawing. The lower part of a brick chimney is against the east wall. There was re-roofing in 1740. Experts have failed to date the beams but most think they were used before 1610 to make this roof on-site. A big low tie-beam crosses the middle of the room, two queen posts slope up from this to long, horizontal purlins, all of these have holes that show they were used in house building before being made into this roof.

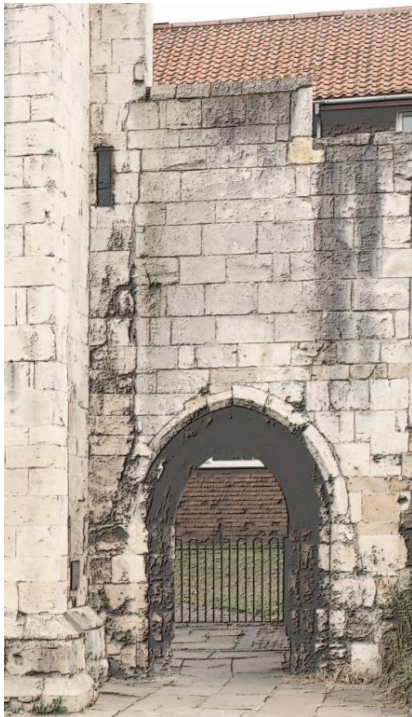
A postern is a small gateway, probably mainly for people on foot. We know of seven posterns into the city; this is the only one left. There probably was a postern here from medieval times, it is named in the city house books of 1440 as 'posterna iuxta ecclesiam Sci. Georgii' (Latin for 'postern next to St George's Church'). It has had its present name since 1548 but in 1642 was still sometimes called St. George's Postern {2}.
